REPORT AMTE(M) R 78004

**THE USE OF CERAMICS IN ENGINES (U)**

D J Godfrey

APRIL 1978

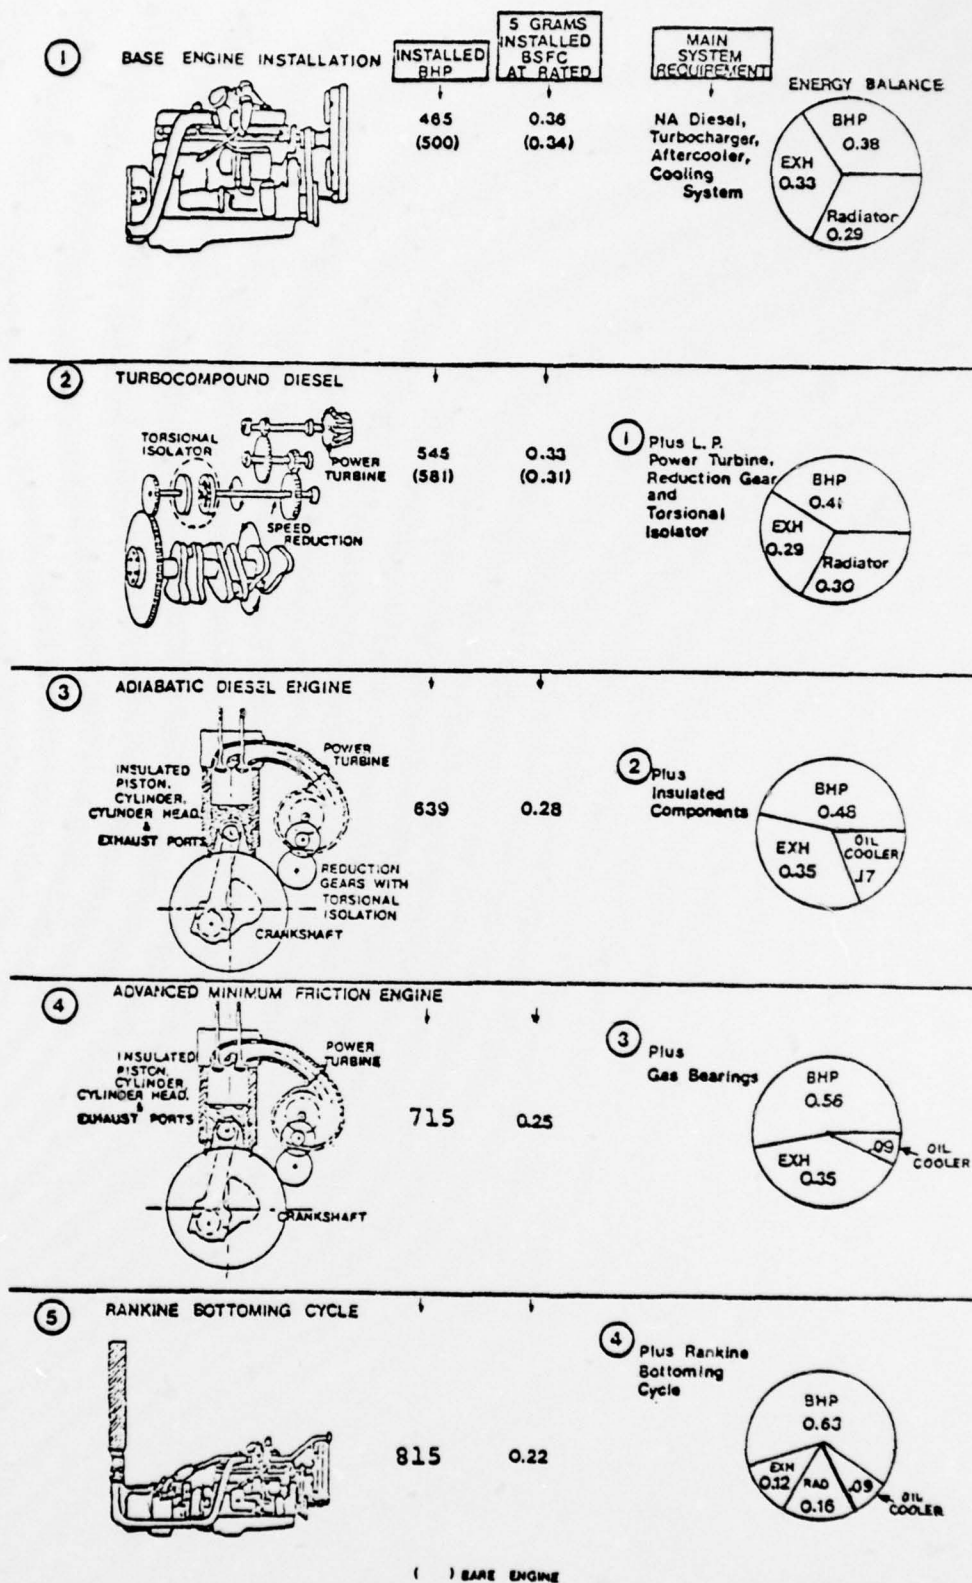
Fig. 6 KAMO's concepts for progressive improvement of diesel engines.  
(copied with permission from Ref 38 Preprint)
